QUEENSLAND DEPARTMENT OF MAIN ROADS

REPORT ON

WONGLEPONG ROAD

RENOLITH - CEMENT STABILISATION

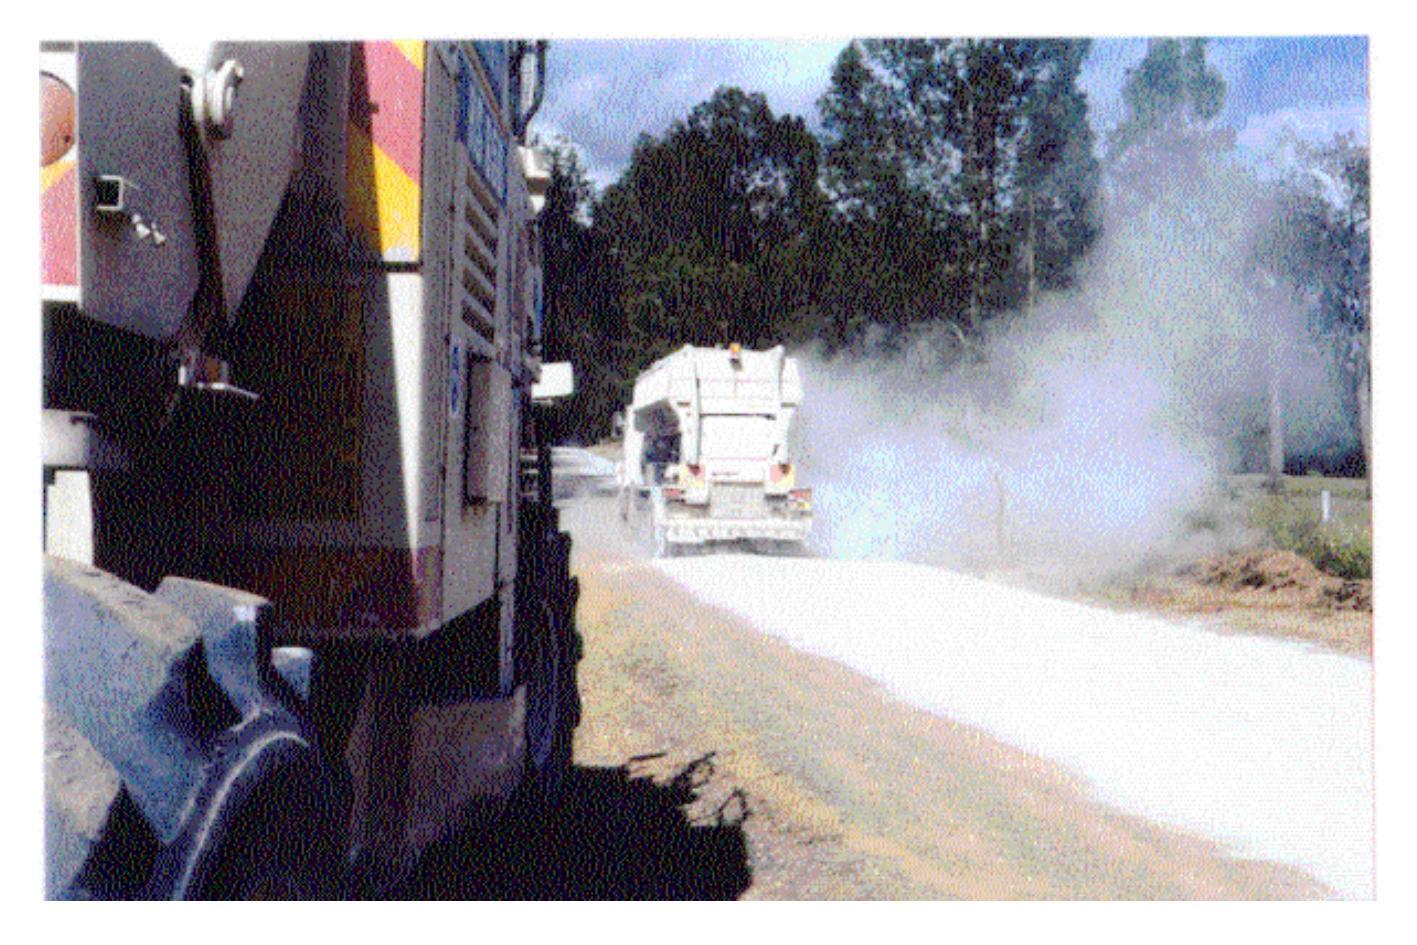
Photo 1 Cement spread over existing pavement material of Wonglepong Road.

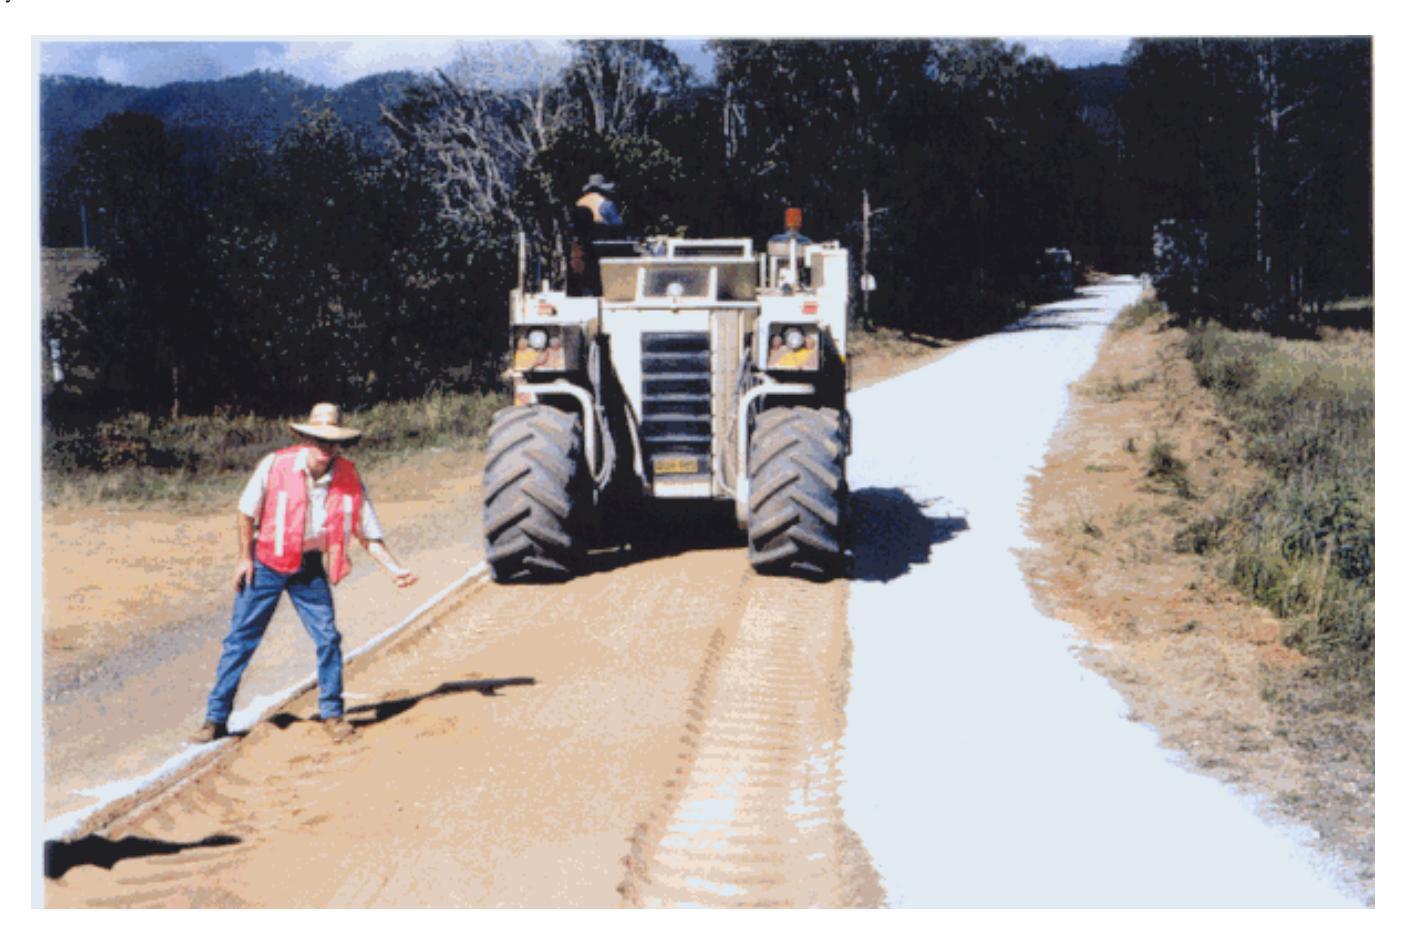
Photo 2 CMI RS-650 Reclaimer mixer unit mixing cement and pavement material to a 200mm depth.

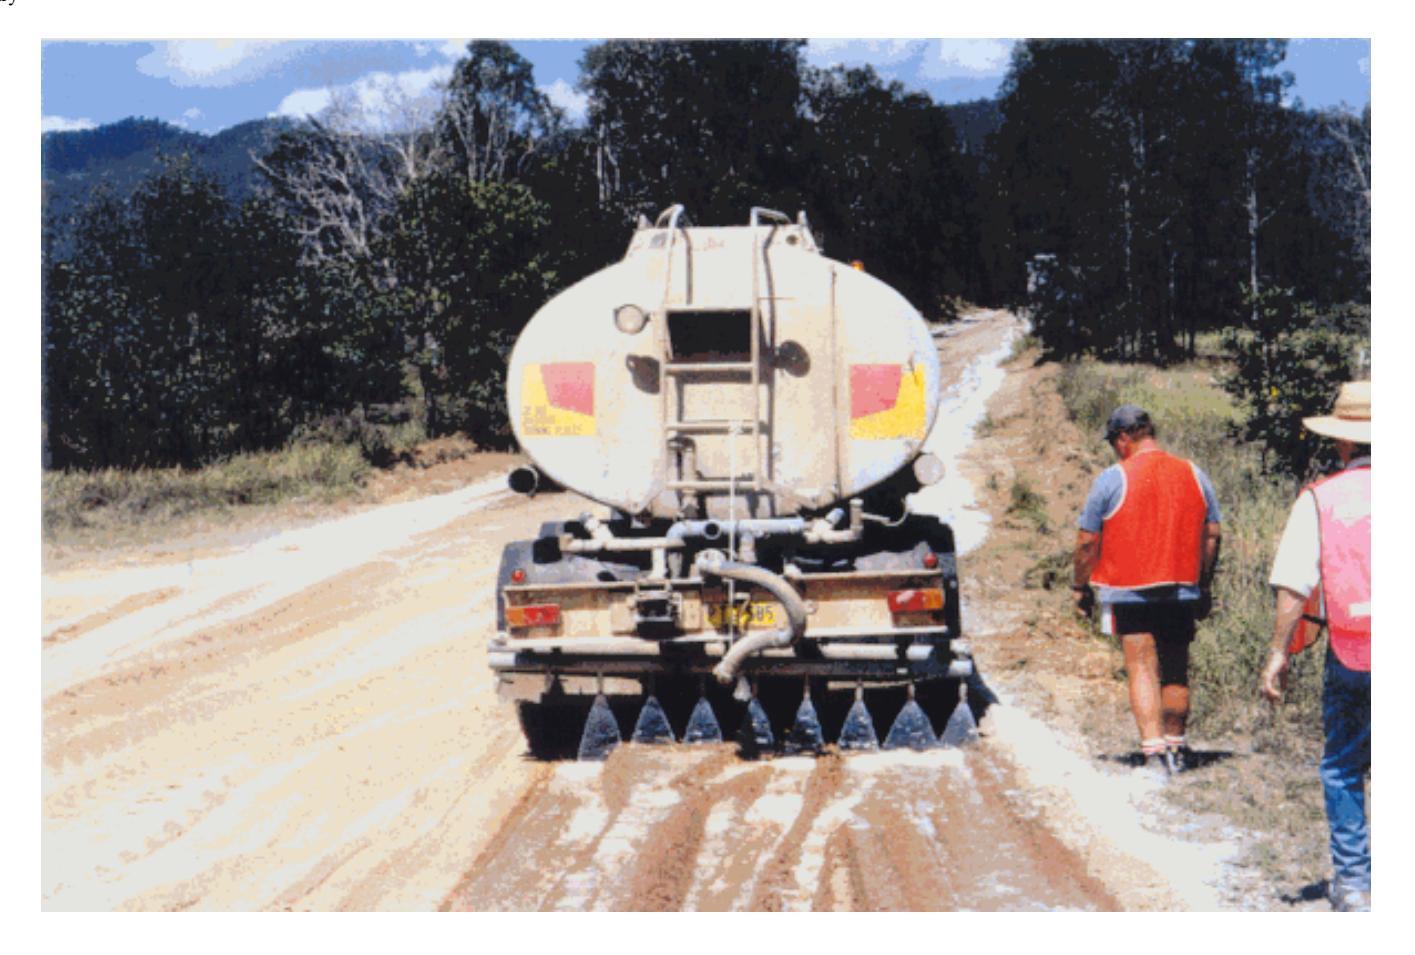
Photo 3 Water truck spraying Renolith / water onto mixed cement pavement material.

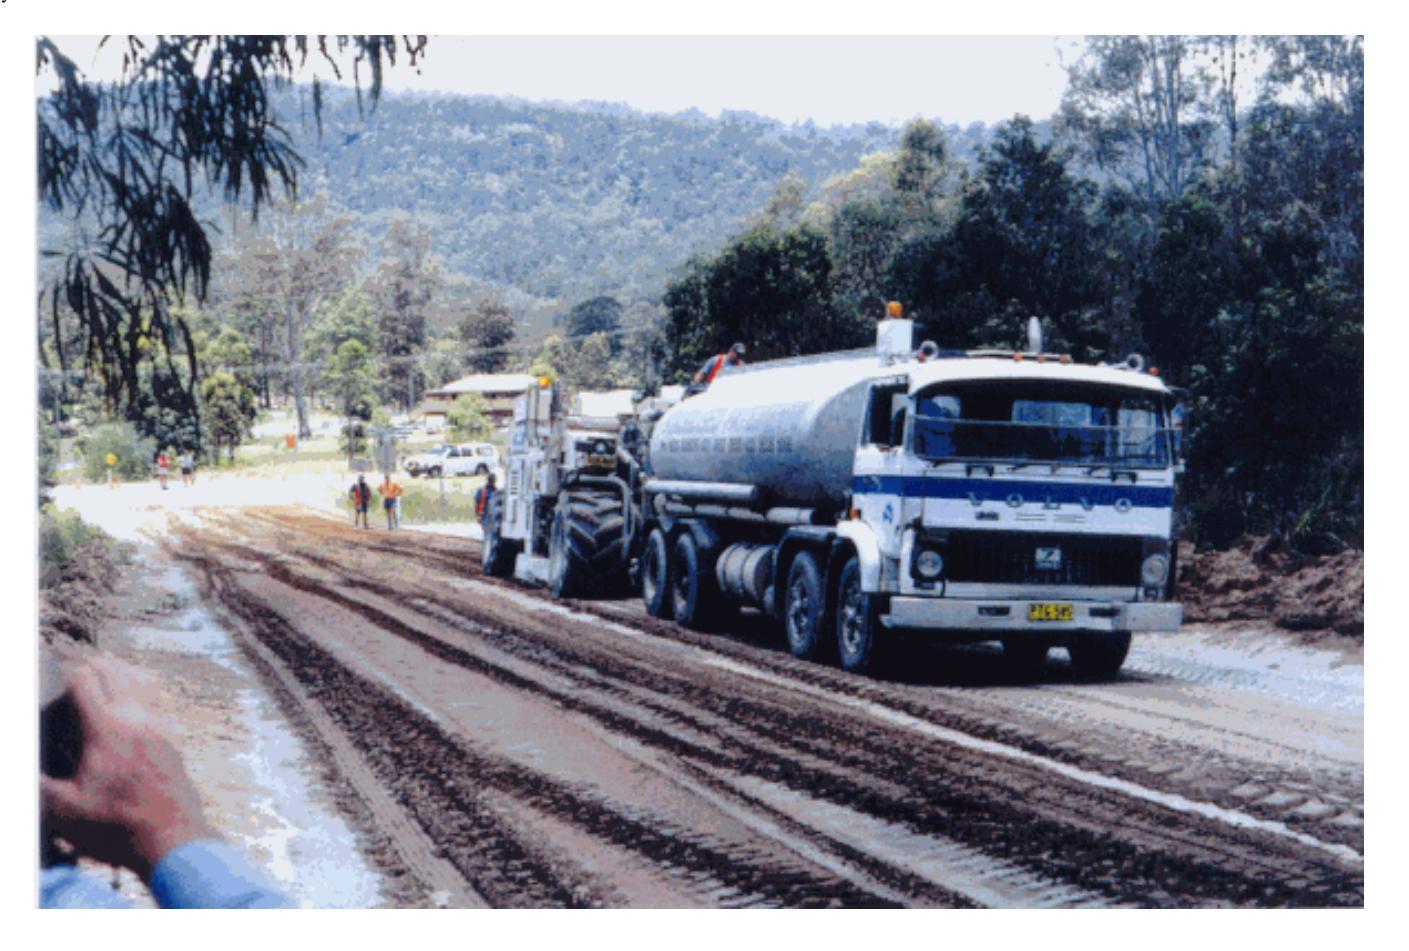
Photo 4 Final mix of pavement by Reclaimer mixer unit direct fed by water truck prior to compaction.

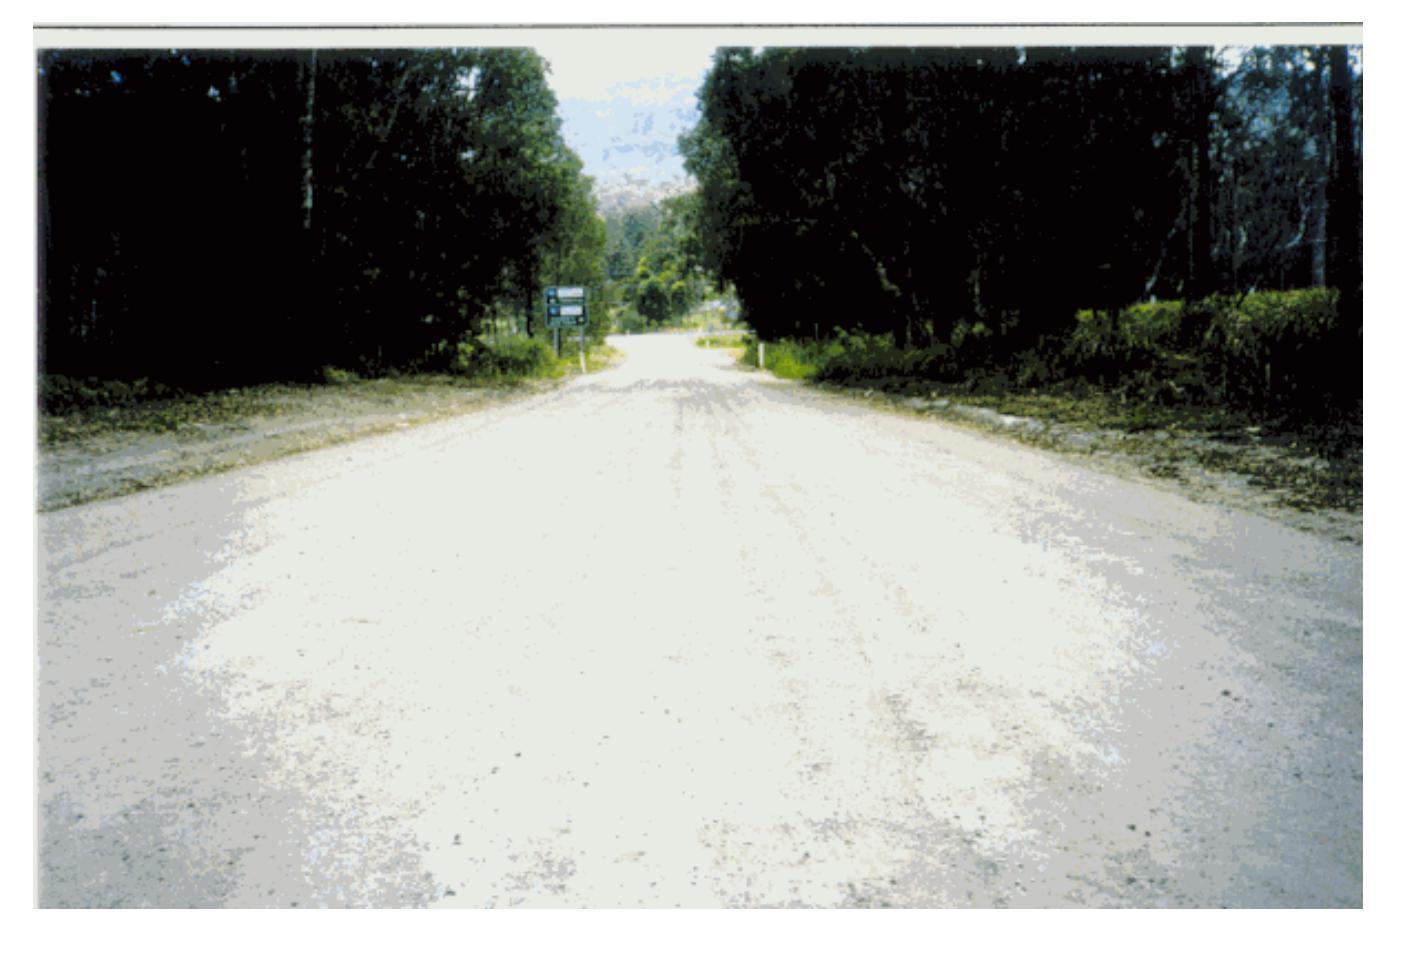
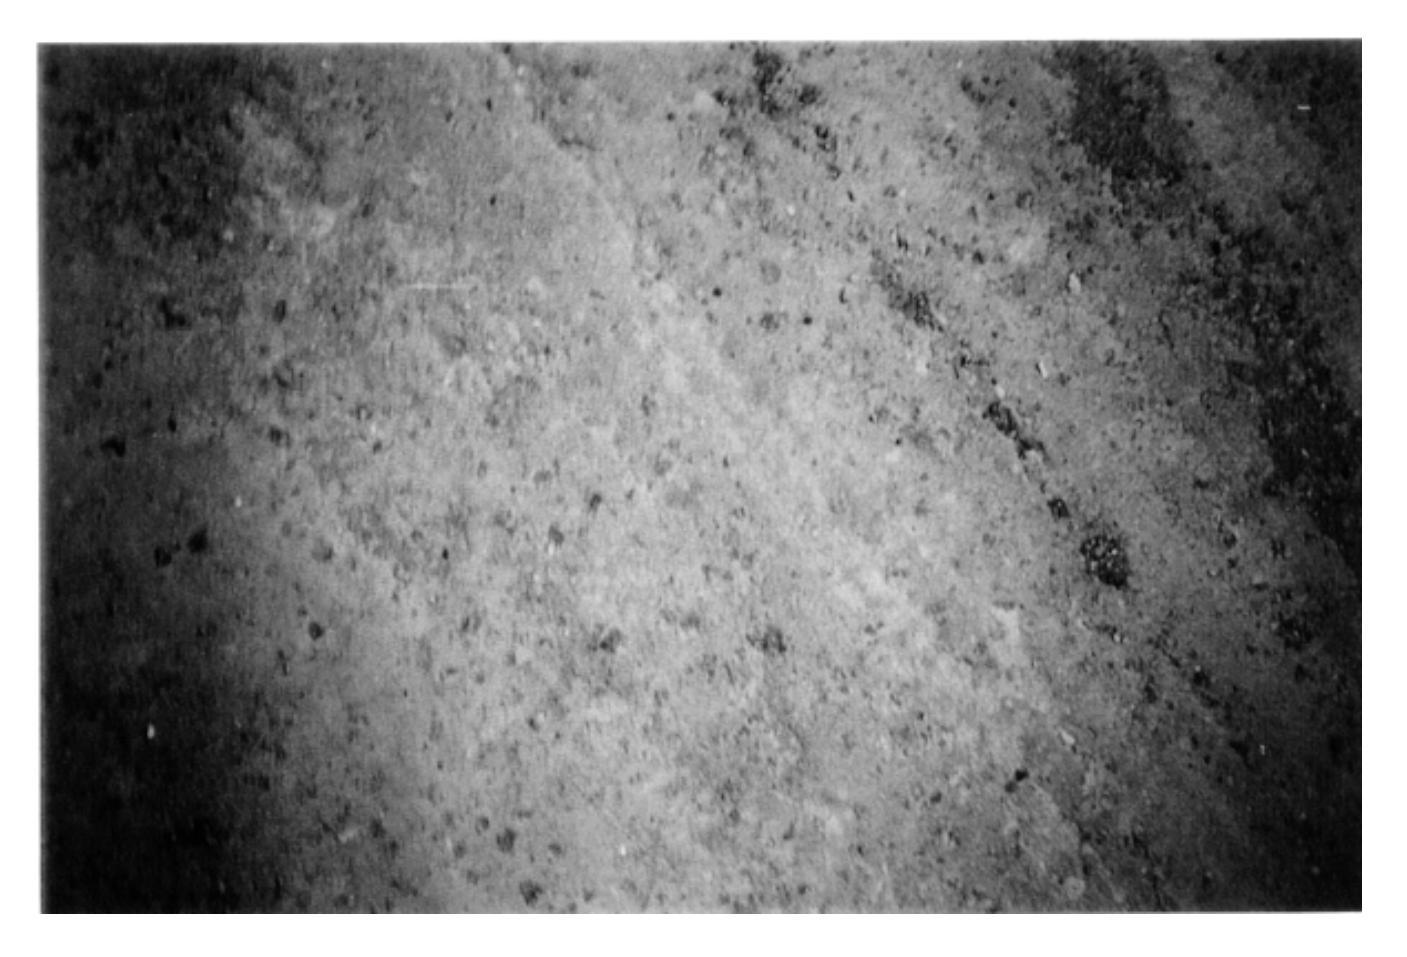
The sandy material is extremely hard with no soft areas and has a smooth finish (Photographs 5 & 6). The orange sandy clay section displays some minor surface cracking which is more evident on the longitudinal graded section when compared to material on flat grades which show minimal or no cracking (Photographs 7 & 8). This is considered possibly to be due to the Renolith application on grade which tended to run off therefore reducing the application rate per square metre to less than designed and also to the higher evaporation rate of water from the sandy clay soils during the hot weather immediately after construction. It was indicated by the Renolith supplier, that the Renolith product would help in binding clayey materials and reduce shrinkage cracks in cement stabilised clay pavements. The surface finish was still smooth with minimal gravel stripping. The black soil pavement has performed well with no evident shrinkage cracking but has some gravel surface stripping (Photographs 9 & 10). The sandy clay soil/gravel pavement has performed very well with only minimal shrinkage cracking noted at the transition to existing gravel pavement. The surface finish is smooth with still a glassy appearance and there is minimal gravel surface stripping (Photographs 11 & 12).

Photo 5 Renolith - cement treated sand pavement section of Wonglepong Road after 7 days.

Photo 6 Renolith - cement treated sand pavement material.

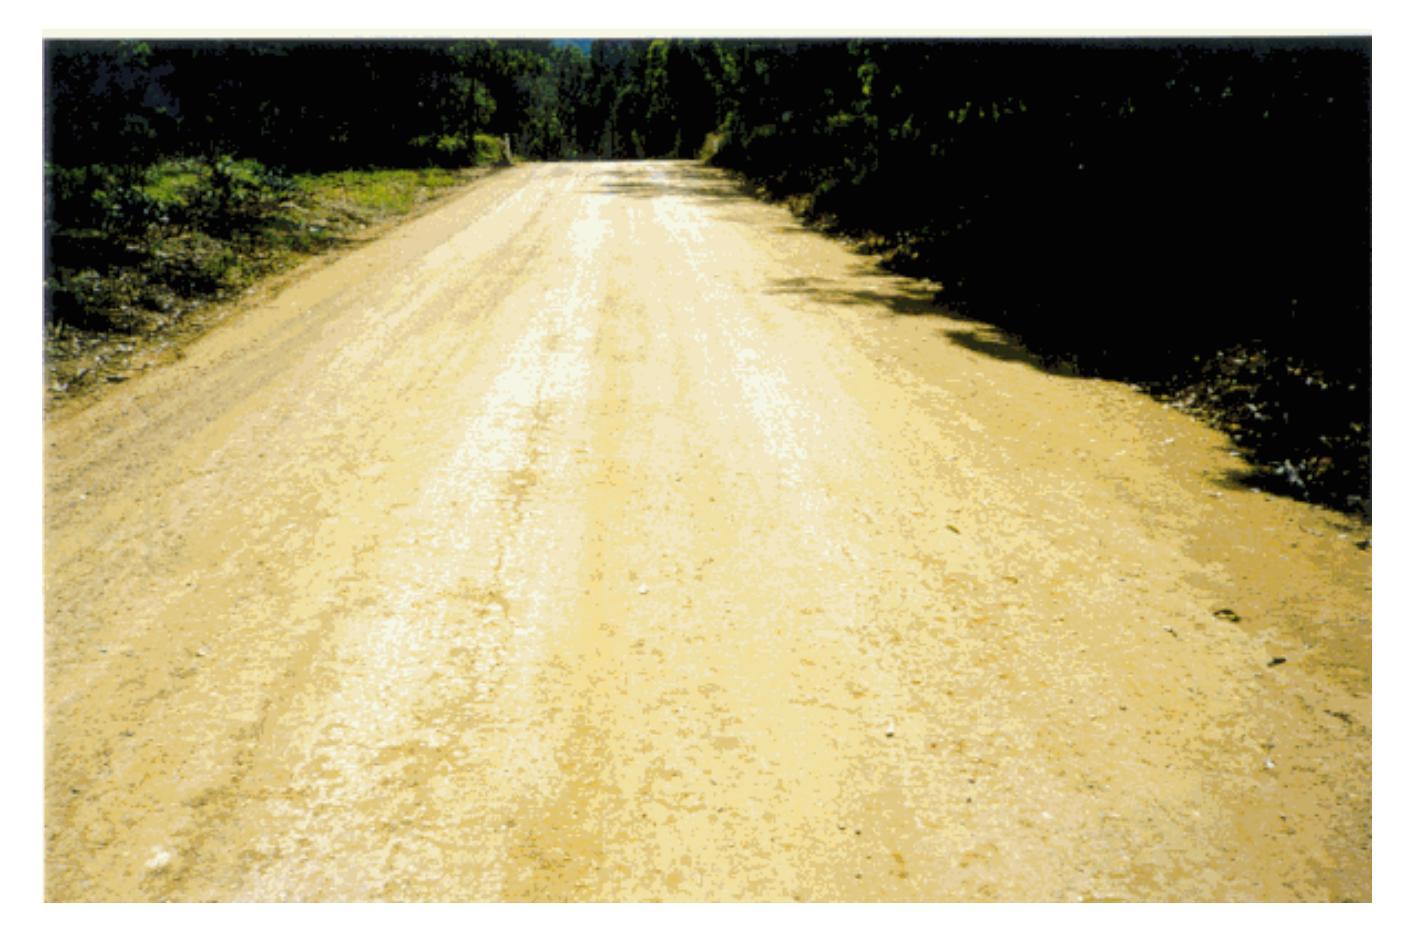
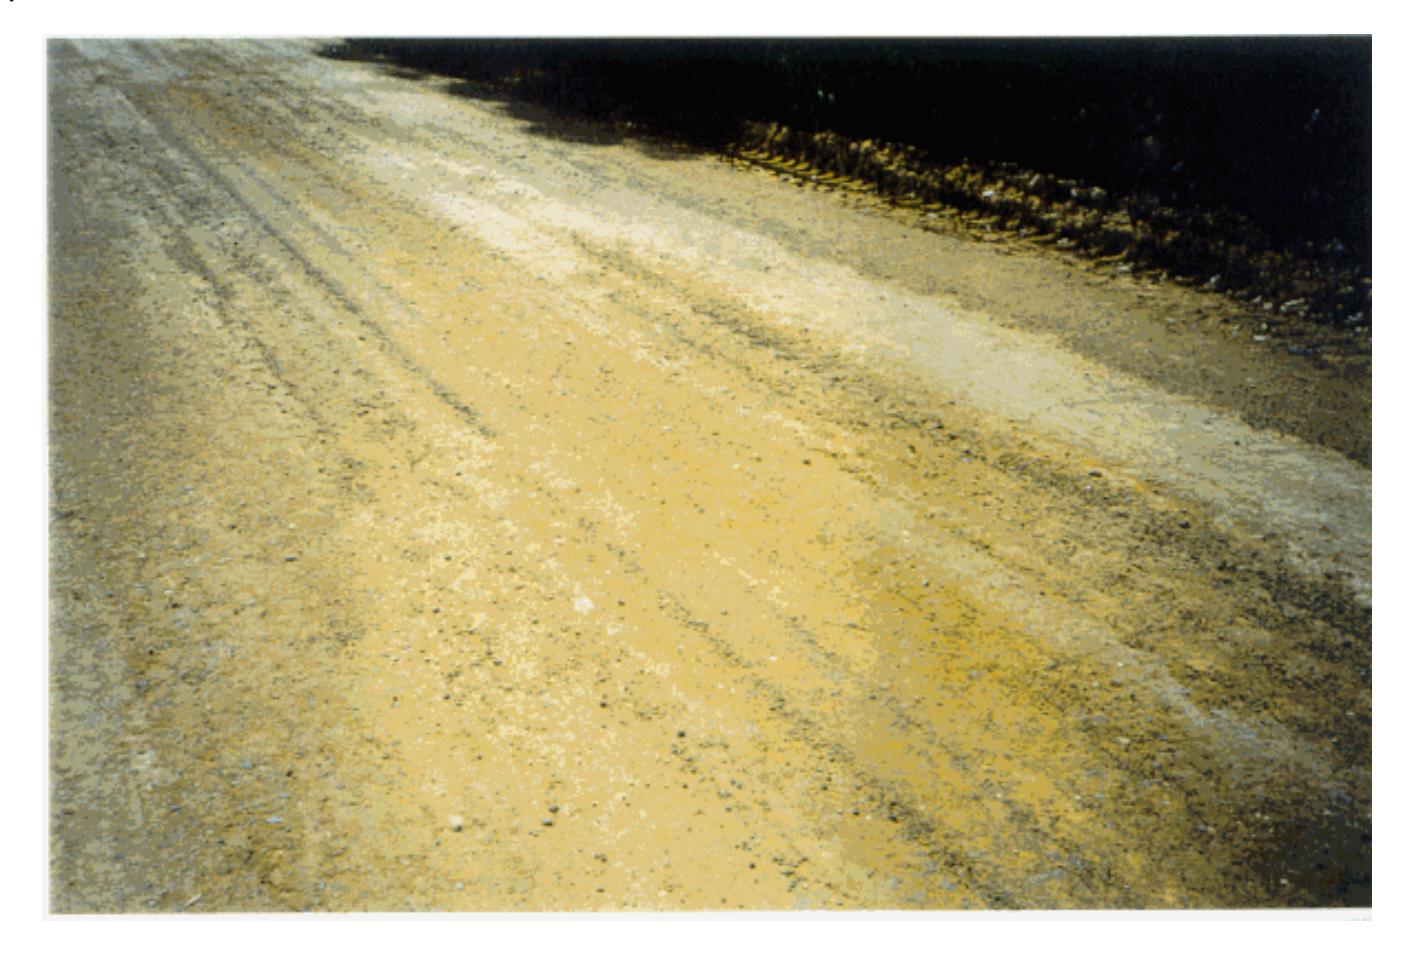
Photo 7 Renolith - cement treated orange sandy clay pavement section of Wonglepong Road after 7 days.

Photo 8 Renolith - cement treated orange sandy clay pavement material.

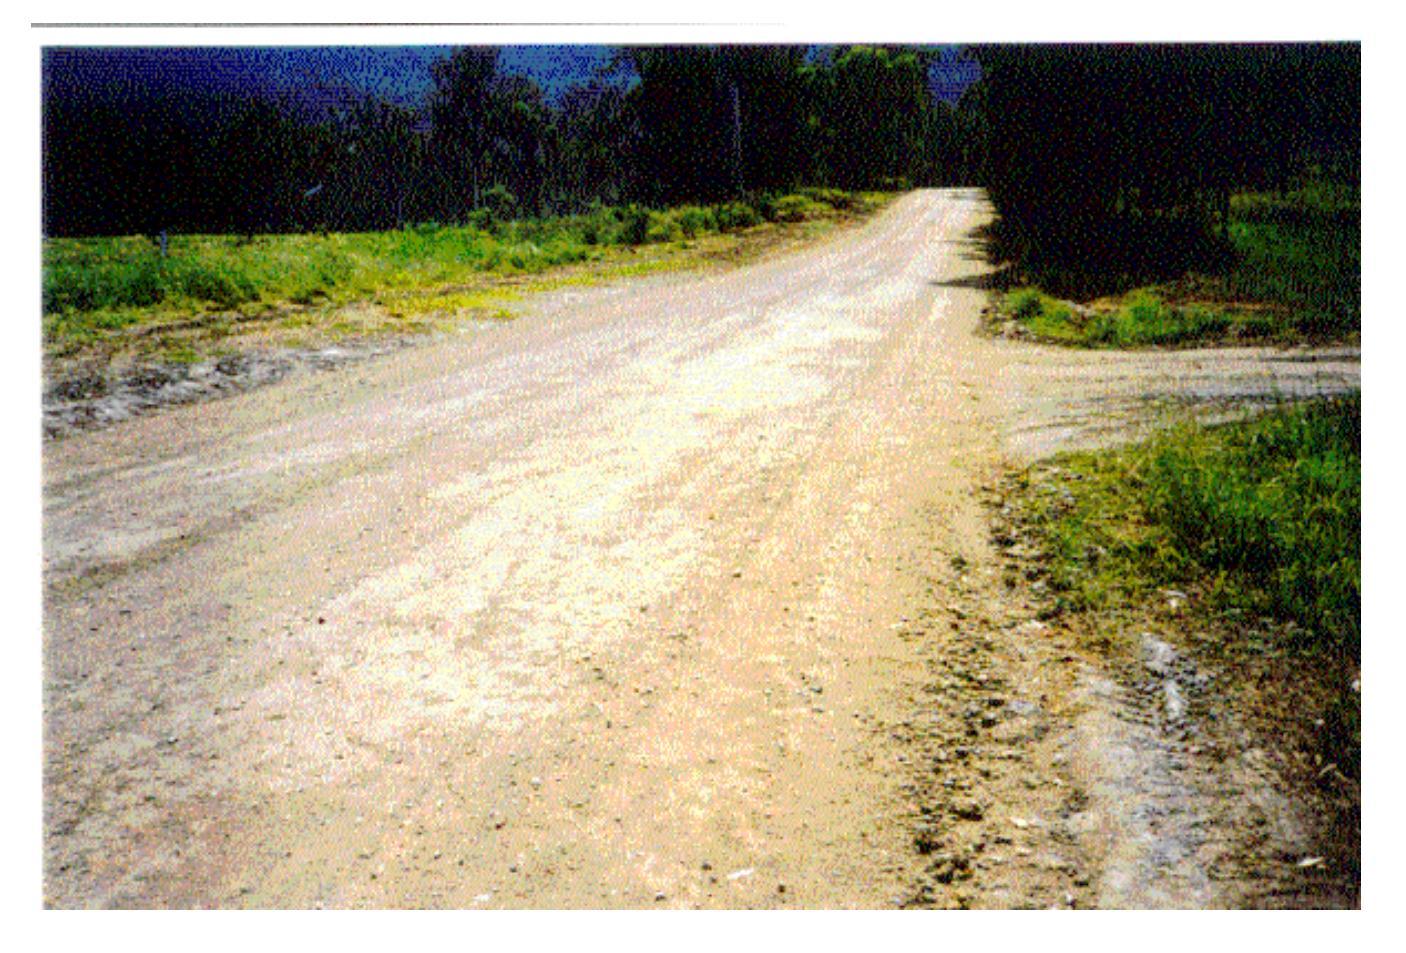
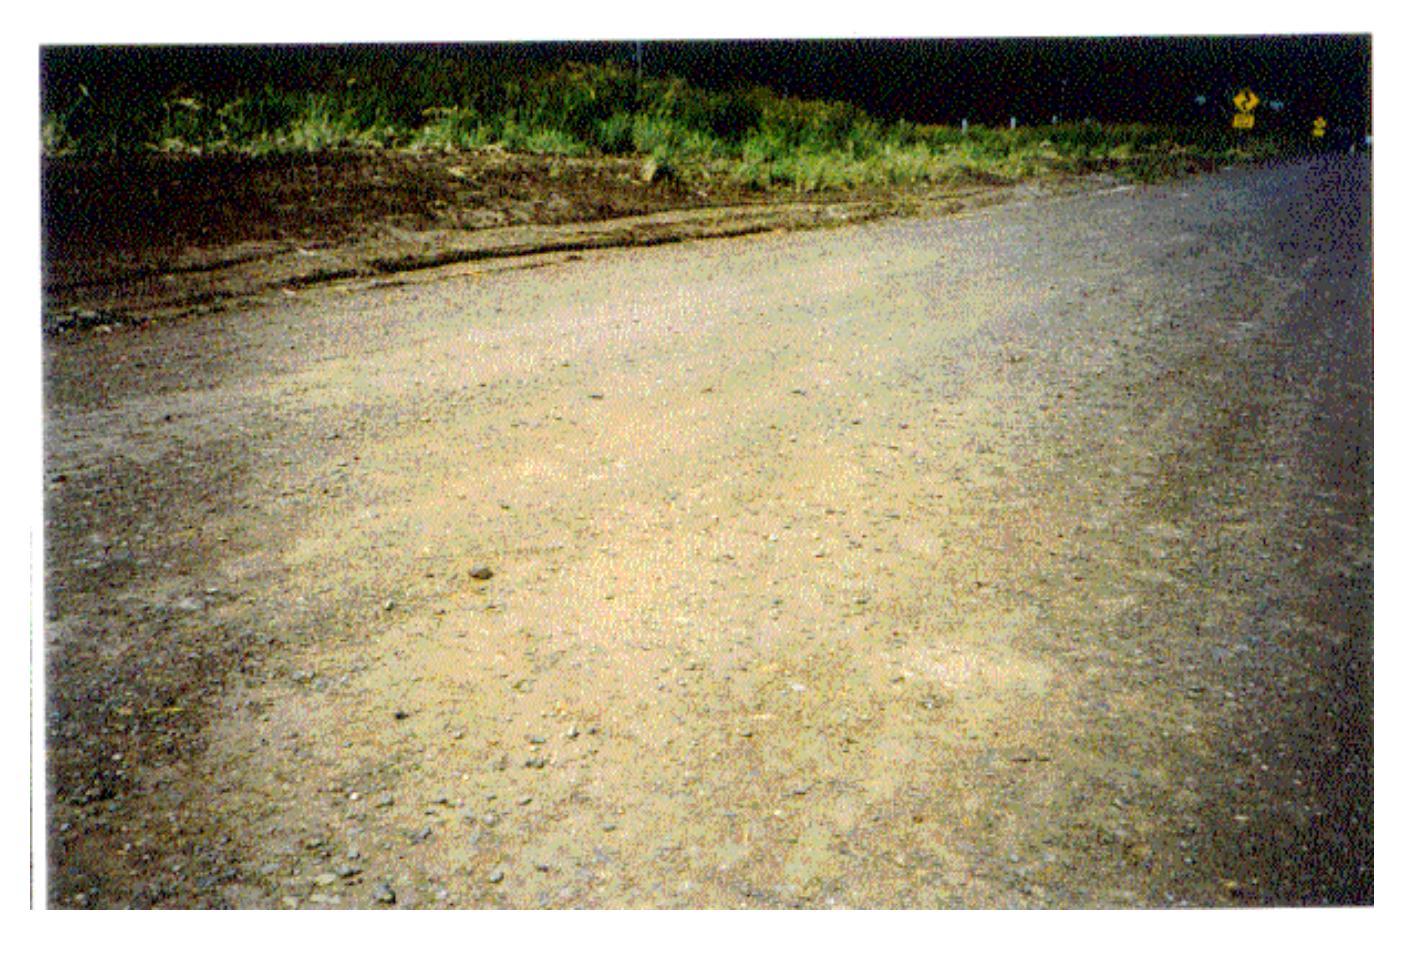
Photo 9 Renolith - cement treated black soil pavement section of Wonglepong Road after 7 days.

Photo 10 Renolith - cement treated black soil pavement material.

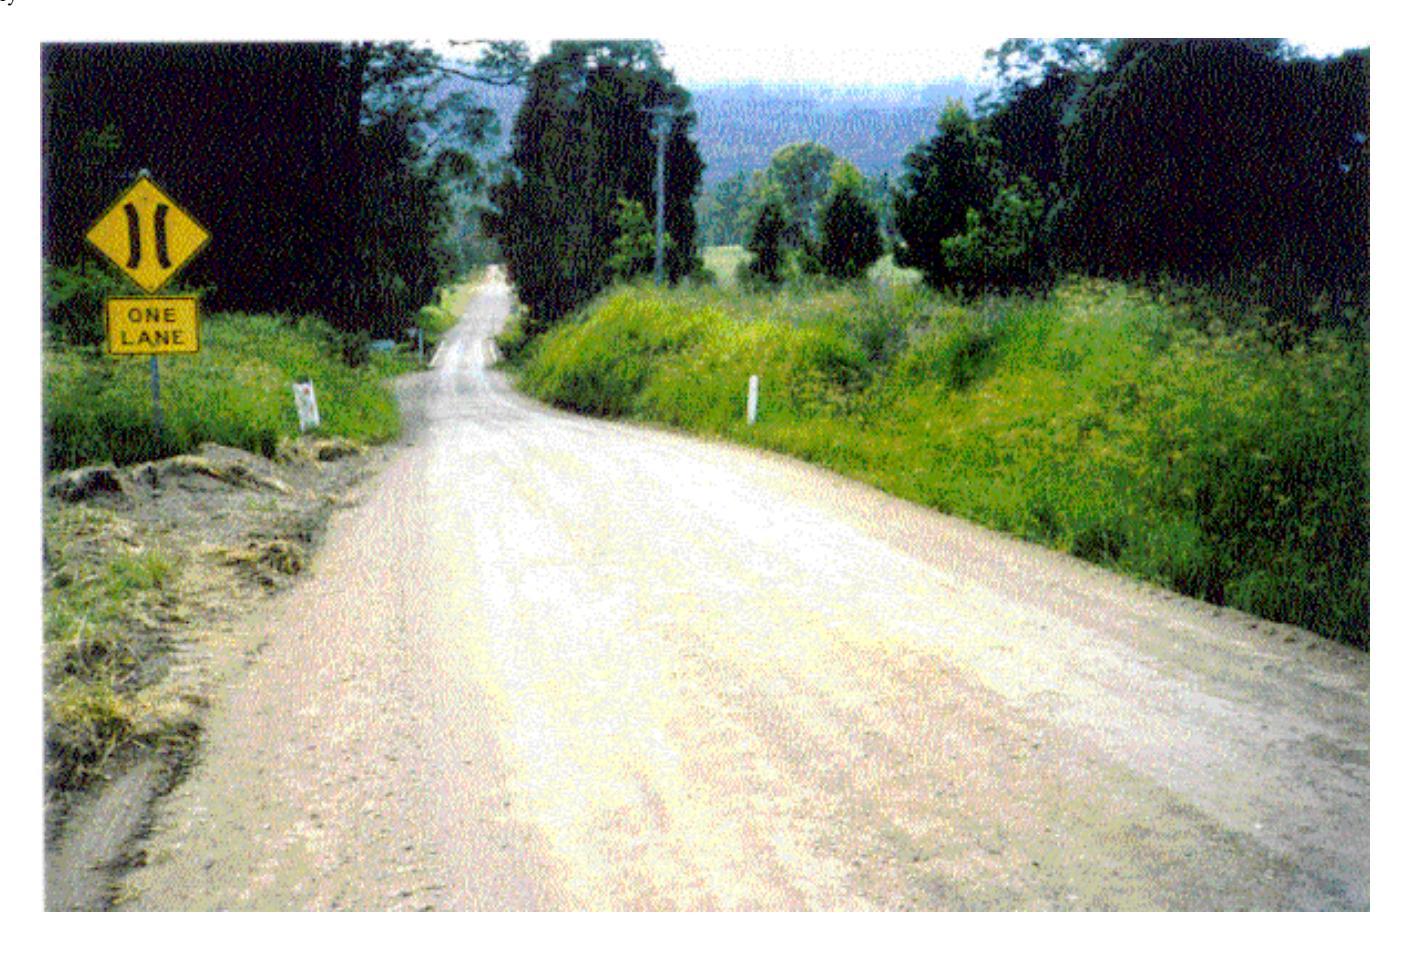
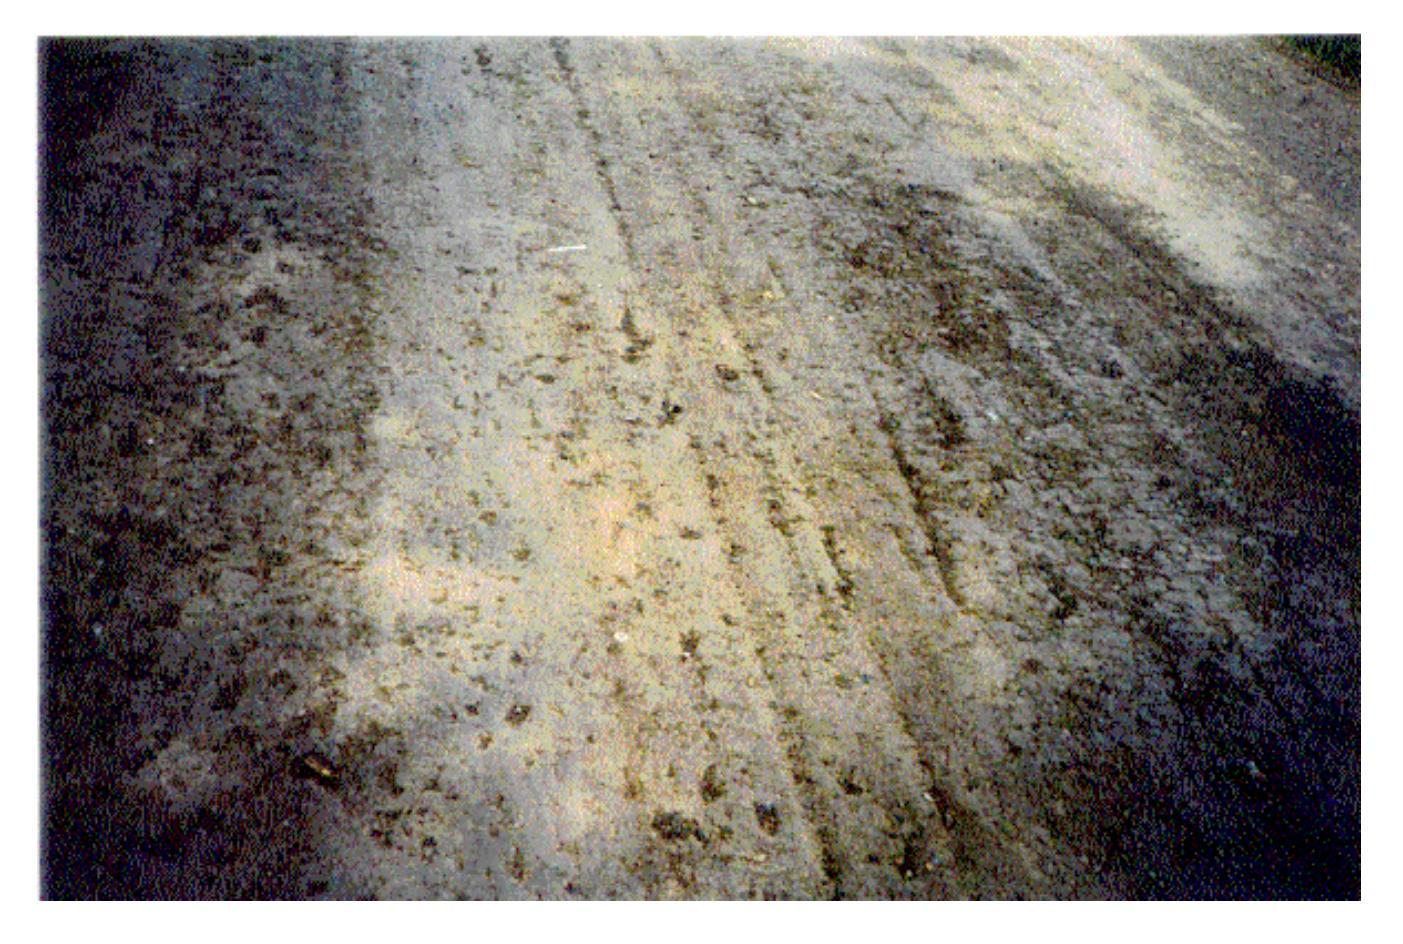
Photo 11 Renolith - cement treated sandy clay soil / gravel pavement section of Wonglepong Road after 7 days.

Photo 12 Renolith - cement treated sandy clay soil / gravel pavement material.

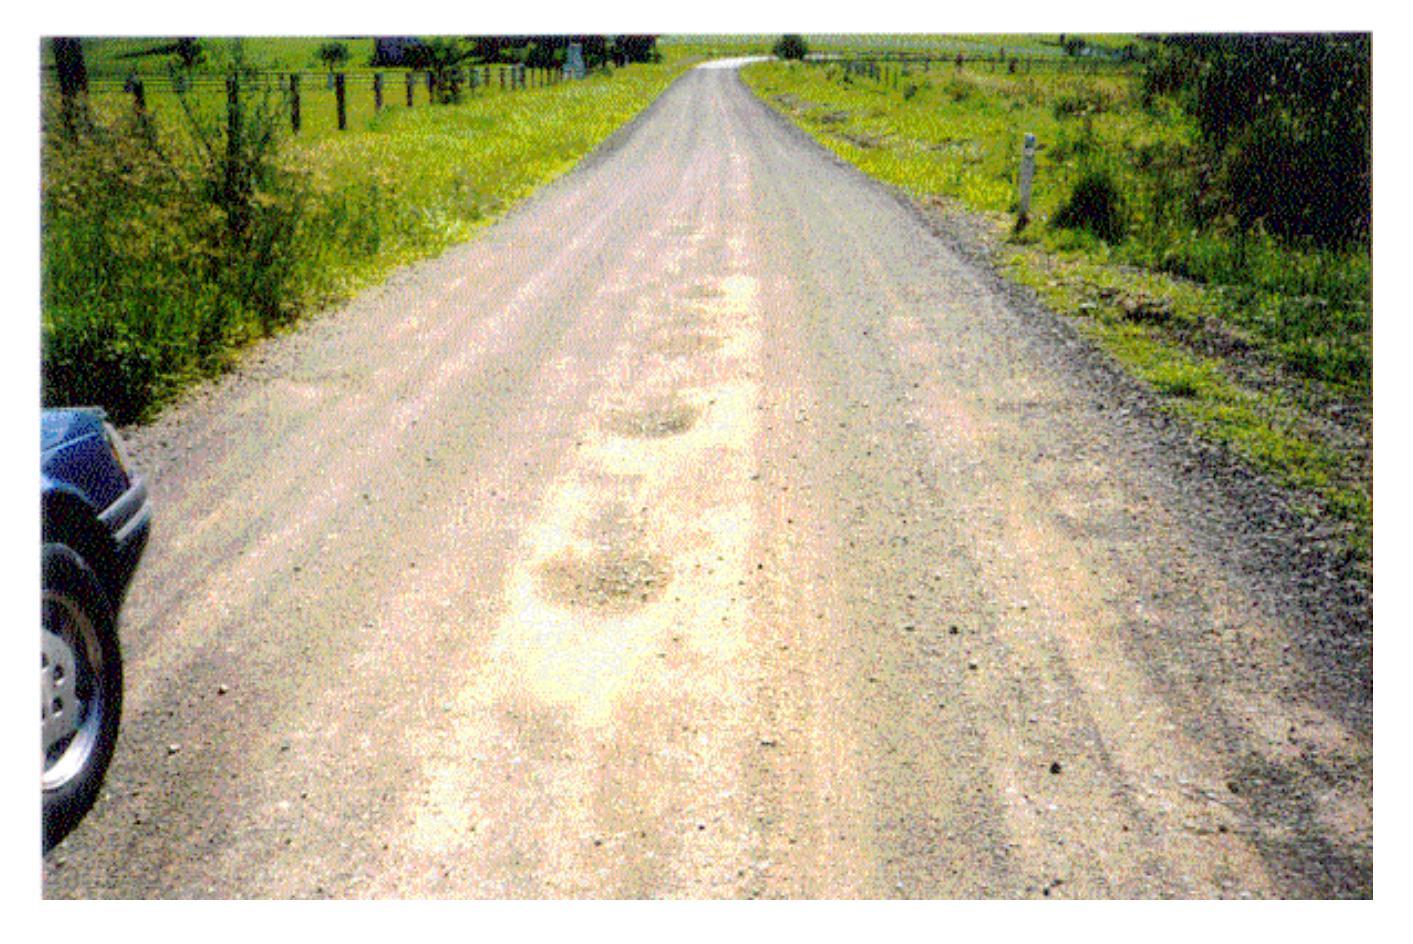
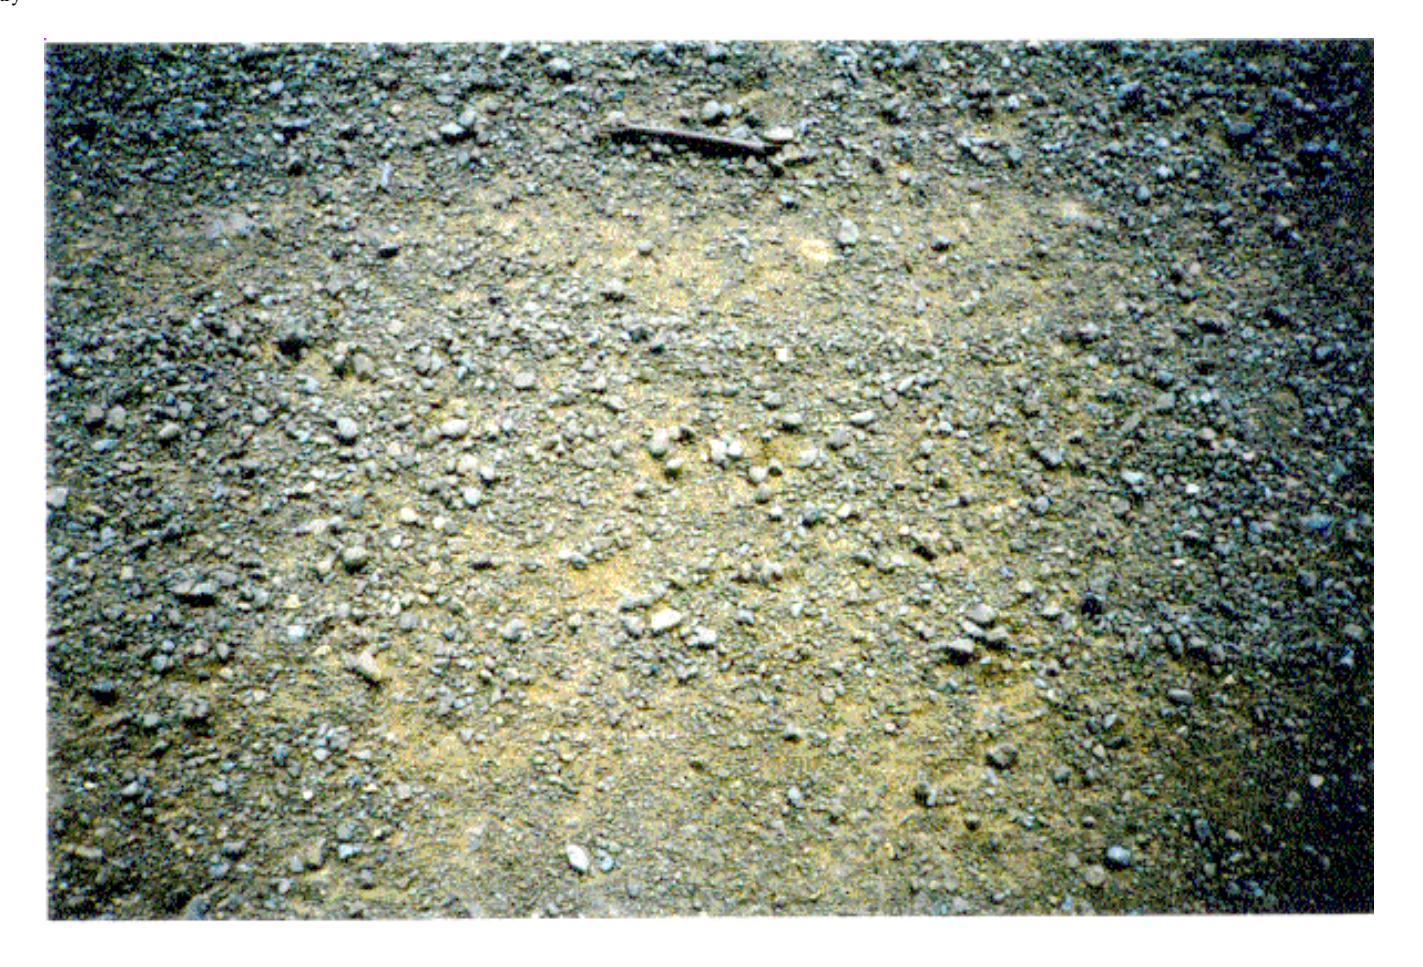
The next 100 metre section on the western side of the bridge rose immediately out of the flood plain up a slight hill and appeared to be a well graded orange / brown sandy clay soil with gravel pavement. Due to the grade of the road at this section, rutting and scours in the table drains were common, but potholes and loose surface gravel did not occur until reaching the existing flatter natural clayey gravel pavement above the flood plain (Photographs 13 & 14).

Photo 13 Wonglepong Road existing pavement after maintenance grading. Note high level of loose gravel on surface.

Photo 14 Loose gravel on surface of existing pavement after maintenance grading.

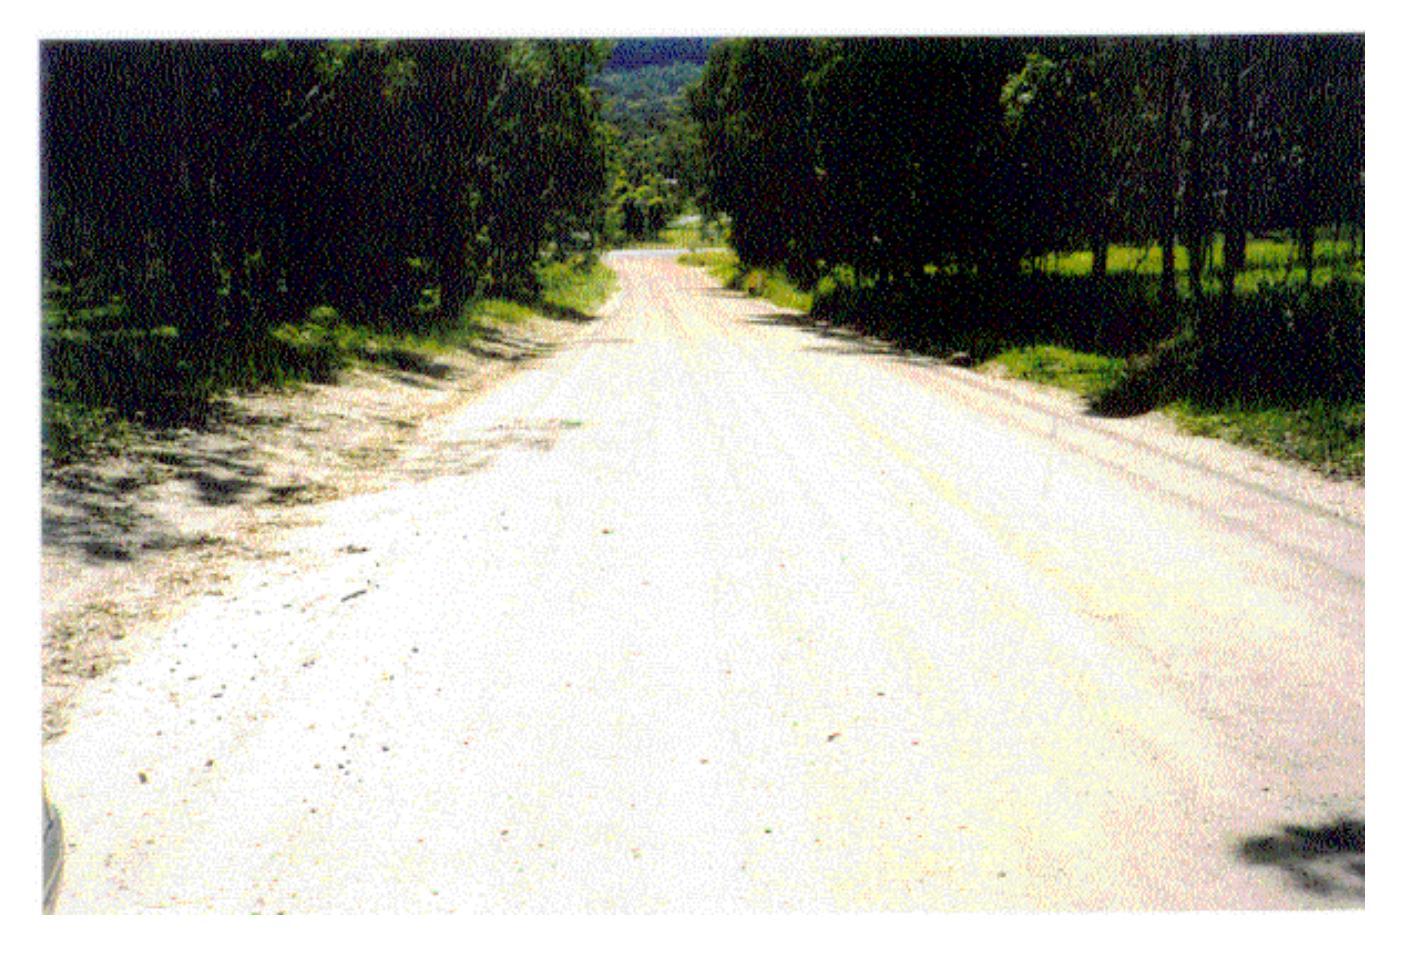
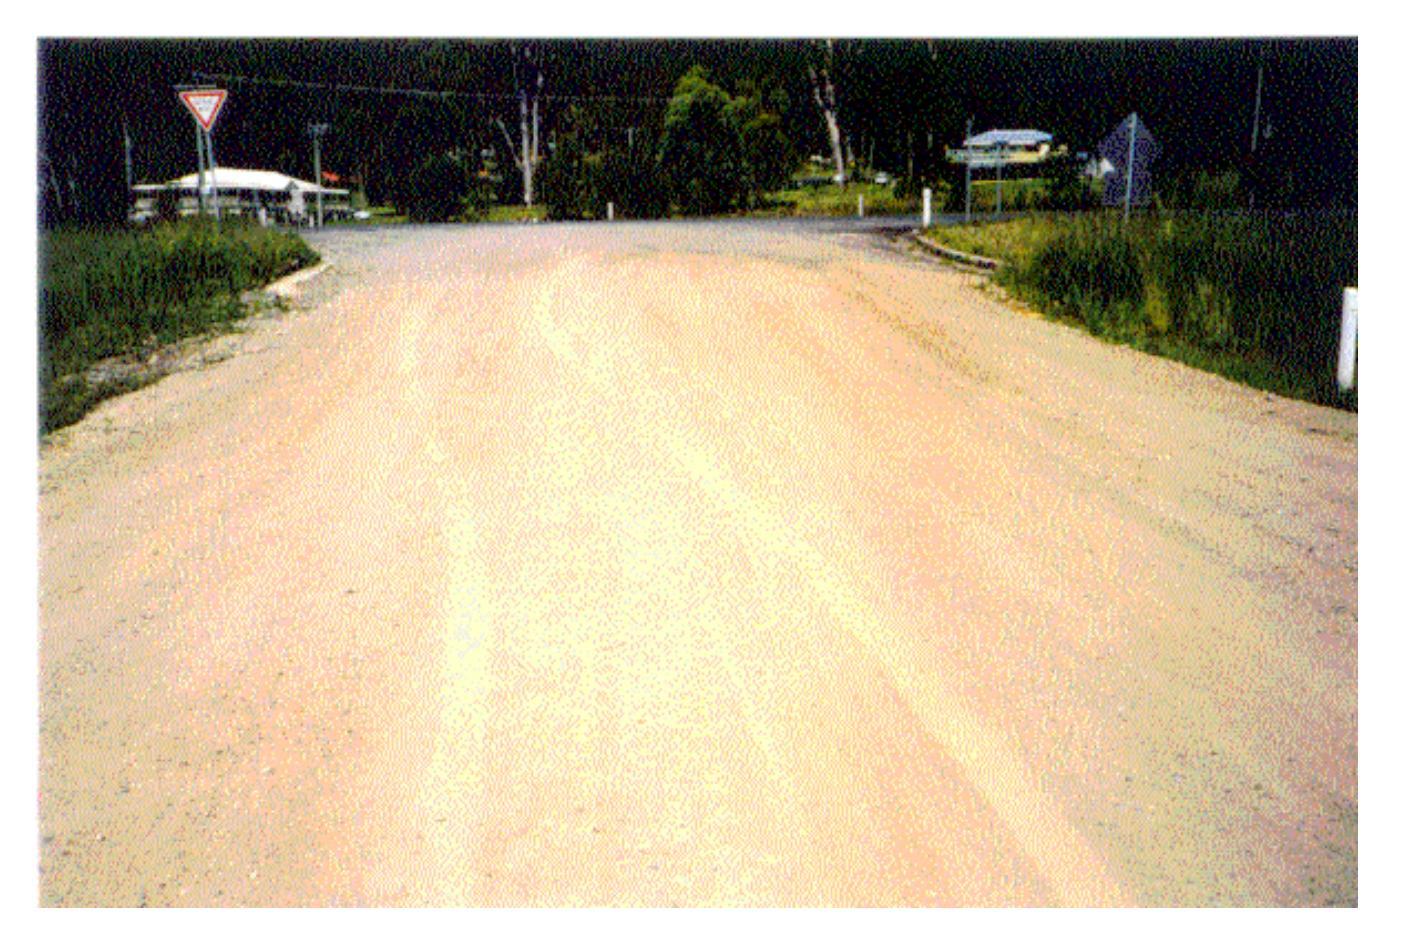
The sandy pavement material had formed some minor sandy patches up the centre line of the pavement. This was unusual as the remainder of the pavement in this section was extremely hard and had a good wearing finish. It is considered that the centre may have had insufficient compaction at the crown after placing of the cement and Renolith and which was only formed by the grader during trimming as the road was layed in two half sections (Photographs 15 & 16).

Photo 15 Renolith - cement treated sand pavement section of Wonglepong Road after 28 days.

Photo 16 Renolith - cement treated sand pavement section of Wonglepong Road after 28 days.
