QUEENSLAND DEPARTMENT OF MAIN ROADS

REPORT ON

WONGLEPONG ROAD

RENOLITH - CEMENT STABILISATION

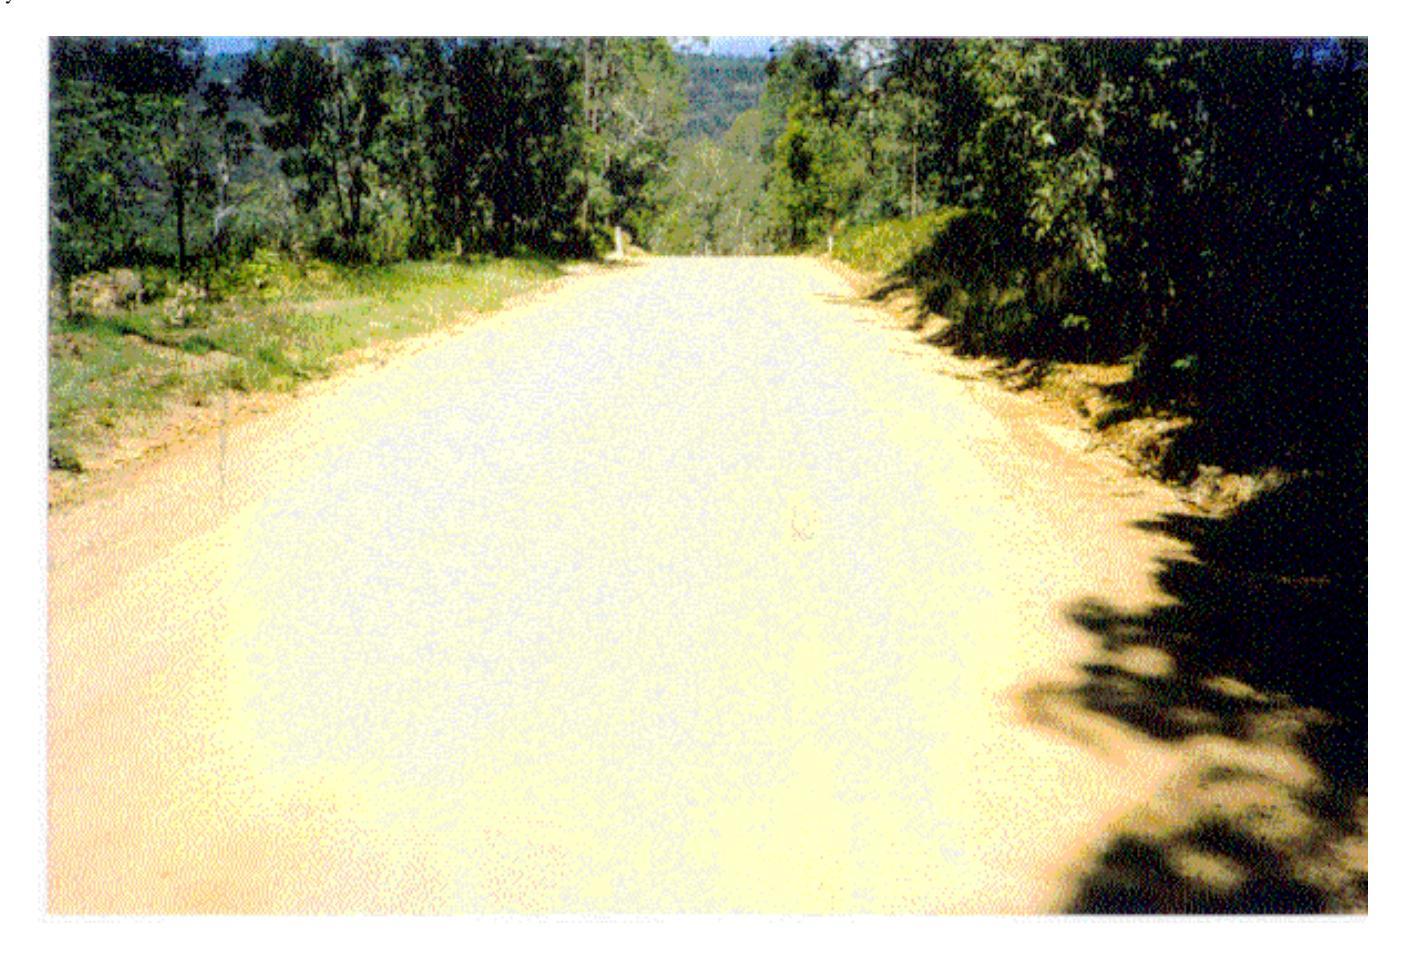
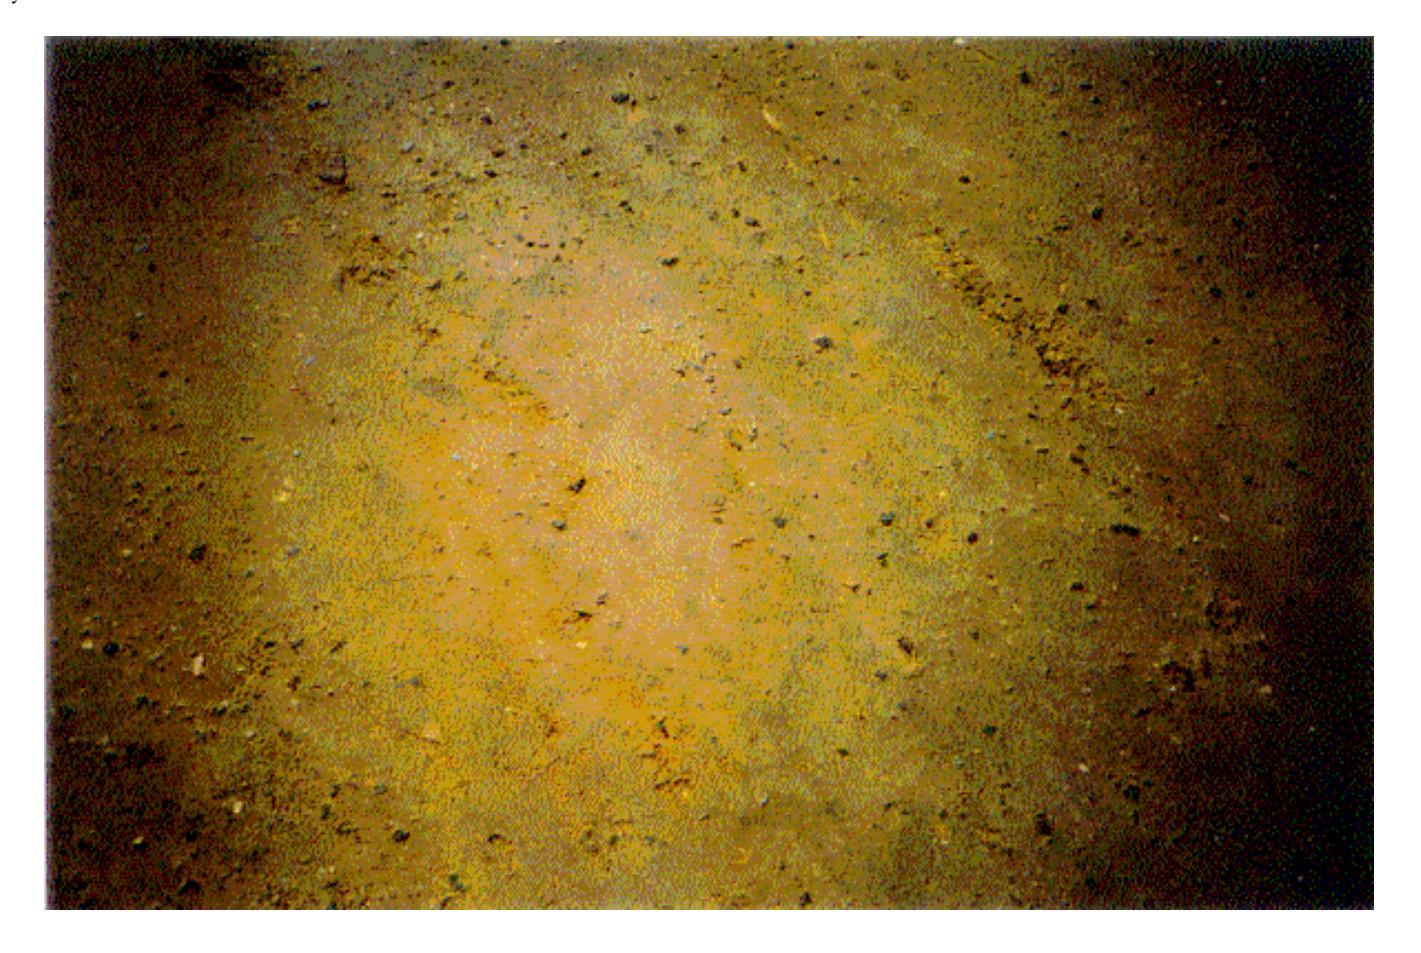
The orange sandy clay section of pavement has performed extremely well. There is minor scouring due to water runoff on the surface close to the table drains, however there was no sign of pavement fatigue, shrinkage cracking, rutting or potholing (Photographs 17 & 18). The contractor did not provide any grading or trimming of this section of road.

Photo 17 Renolith - cement treated orange sandy clay pavement section of Wonglepong Road after 28 days.

Photo 18 Renolith - cement treated orange sandy clay pavement section of Wonglepong Road after 28 days.

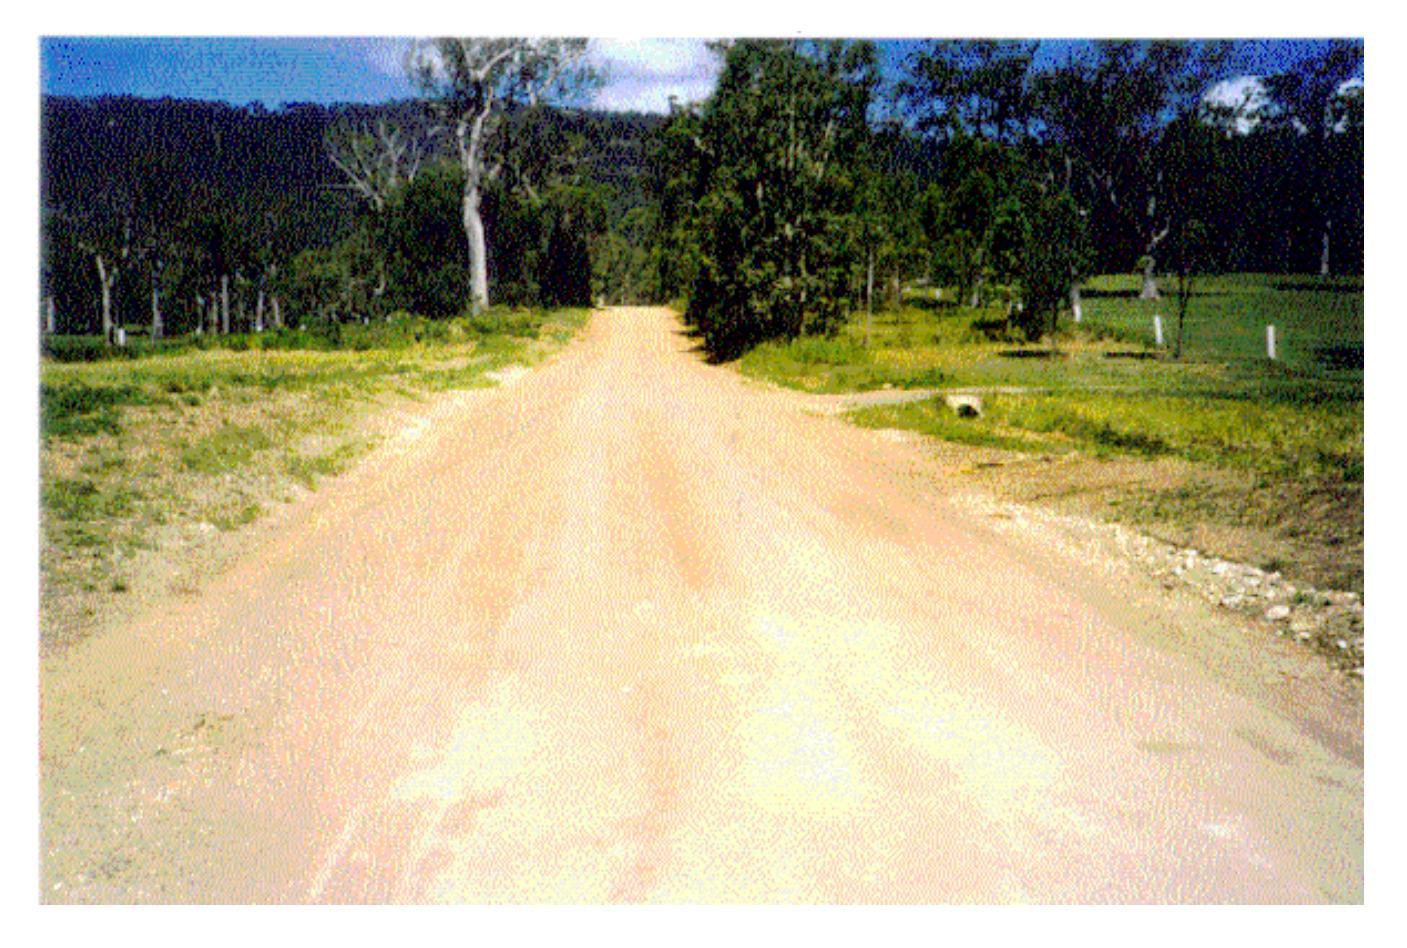
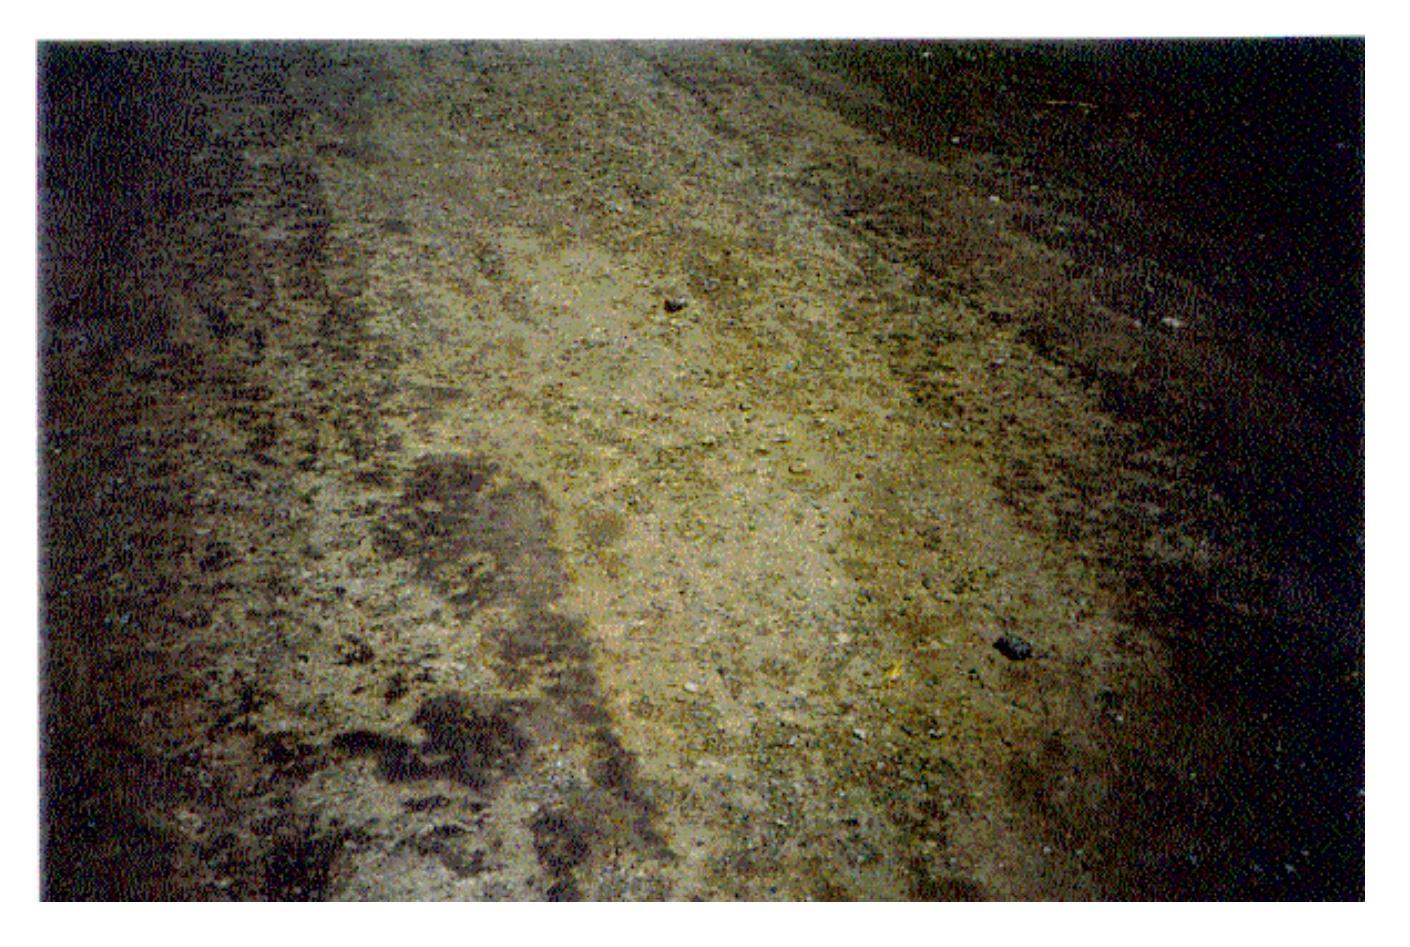
The blacksoil section of pavement when inspected at 14 days displayed minor potholes randomly positioned across the pavement, however the integrity of the pavement appeared to be firm and complete (Photographs 19 & 20). However we have been advised that the contractor has remixed the top 200 millimetres of pavement material, recompacting and grading. This was apparently due to further potholing of the running surface which was not apparent at the 28 day inspection. The supervisor of the Council construction force has indicated that during initial construction, the amount of rain that fell on the afternoon of 16 December had caused the quantity of cement and Renolith applied to be reduced and hence had meant that the pavement was not completed adequately and that they were remixing and recompacting this section only of the pavement. Unfortunately this action which apparently was not referred to the DMR, the supplier of the Renolith nor the supervising engineers will negate any potential residual benefit of the Renolith-cement treated pavement, as was originally placed in this section, for trial and testing purposes.

The black clay soil section of the road showed some signs of becoming crazed and potholed and it is our opinion that this occurred due to the storm and that inadequate cement and Renolith remained and was available in the pavement mix to hold the soil pavement together and to reduce the potential for shrinkage of these highly plastic soils (PI 1 16 to 20). The actions by the Council have negated the ability to obtain results of any testing being undertaken but visual observation of this section of the road shall be maintained and at the 28 day inspection appeared to be of a good condition.

Photo 19 Renolith - cement treated black soil pavement section of Wonglepong Road after 28 days.

Photo 20 Renolith - cement treated black soil pavement material at bridge approach after 28 days.
